Buckland Historical Society

Architectural Restoration and Educational Resource Plan

For an English Style Barn
at the Wilder Homestead Property

Structural Assessment Prepared by:
Stevens & Associates, P.C. June 17th, 2020

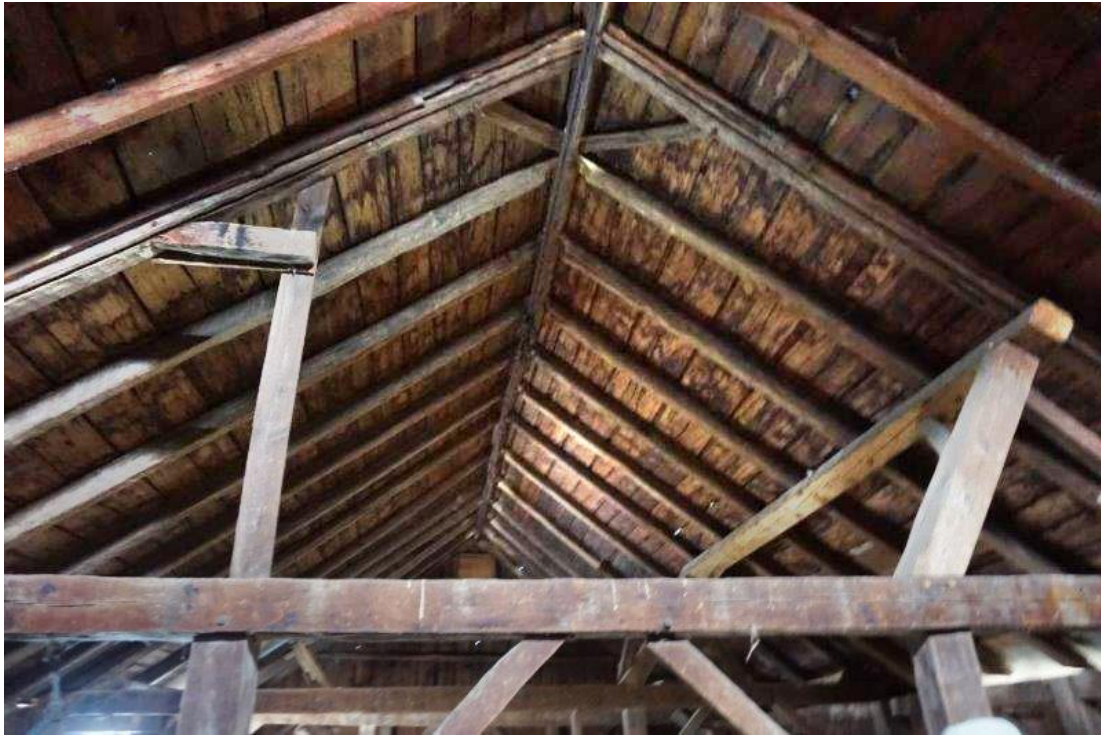
ROOF BRACING: Antique barn looms, temporary bracing supports one bay of the barn roof, where a structural failure occurred. The post and beam framing will be reconstructed at this area, to eliminate the need for bracing, and return to the original farming appearance.

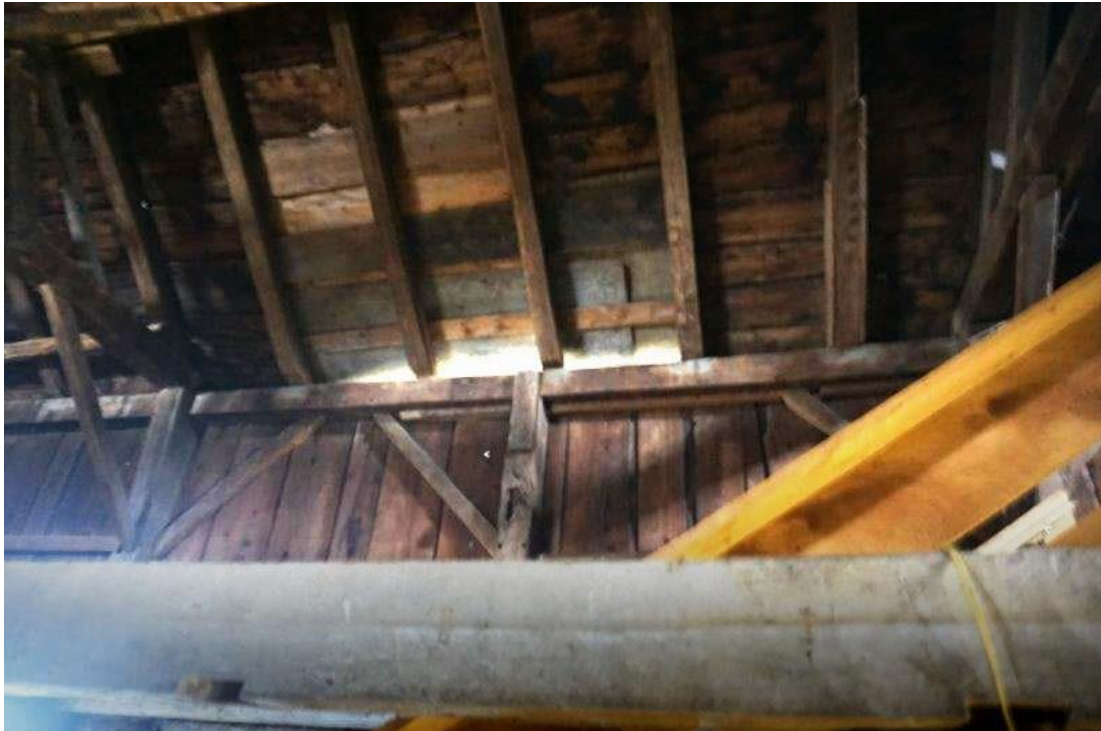
RAFTER BEARING: The rafters below the temporary bracing have lifted up off of the top girt, where they were originally bearing.

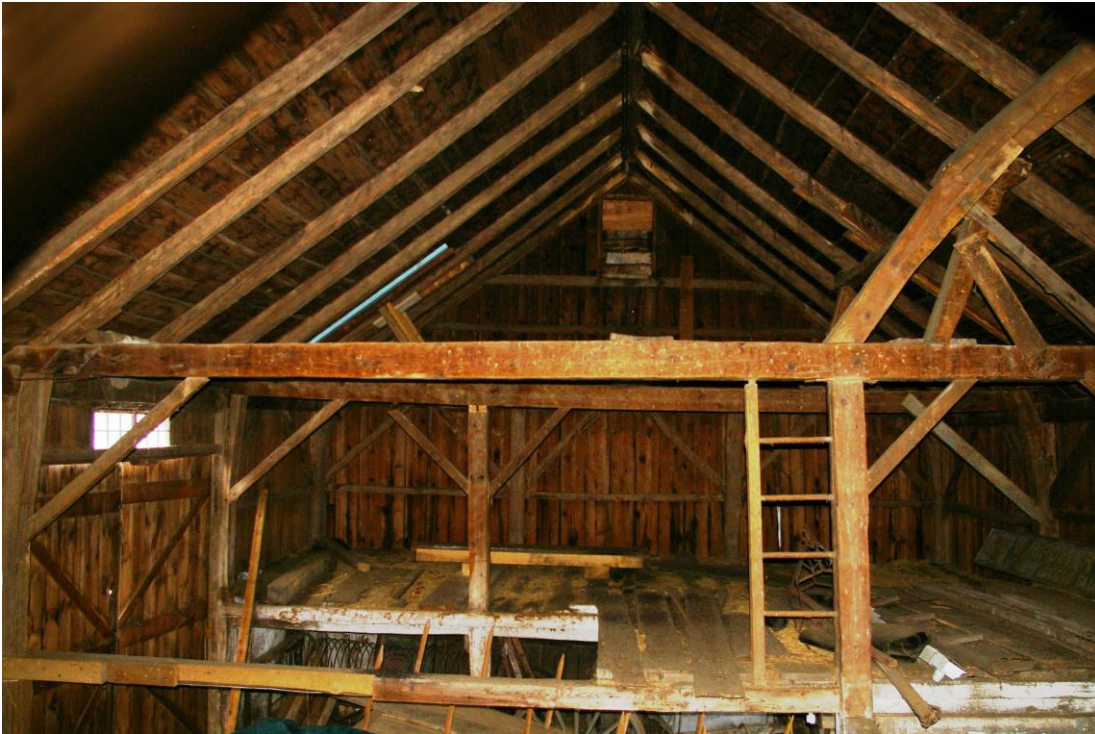
TIMBER FRAMING FAILURE: The post and two braces at the hayloft, beyond the threshing floor, have dropped and their connection to the girt above has completely failed, due to a post removed from the girt below, resulting in substantial sag over a long span.

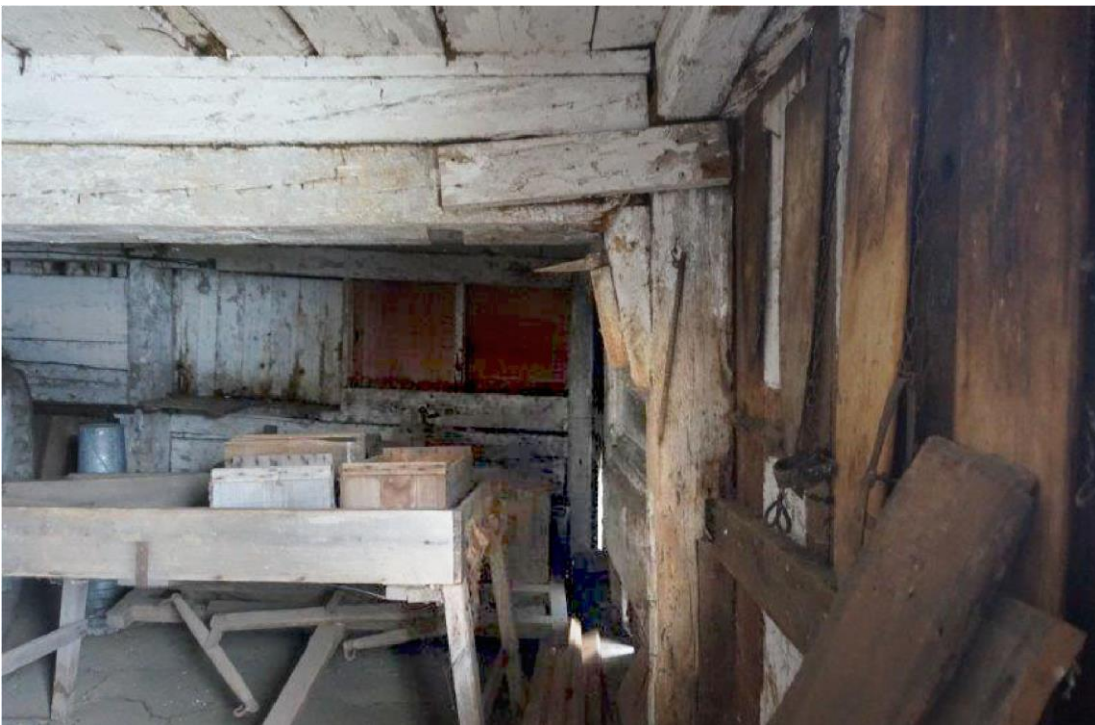
POST TO GIRT CONNECTION FAILURE: The post to girt connection has failed, with a second timber added below the original girt, a blocking added where the timber meets the post, and a spline

nailed alongside the connection. A proper connection needs to be restored, with timber replacement as necessary.

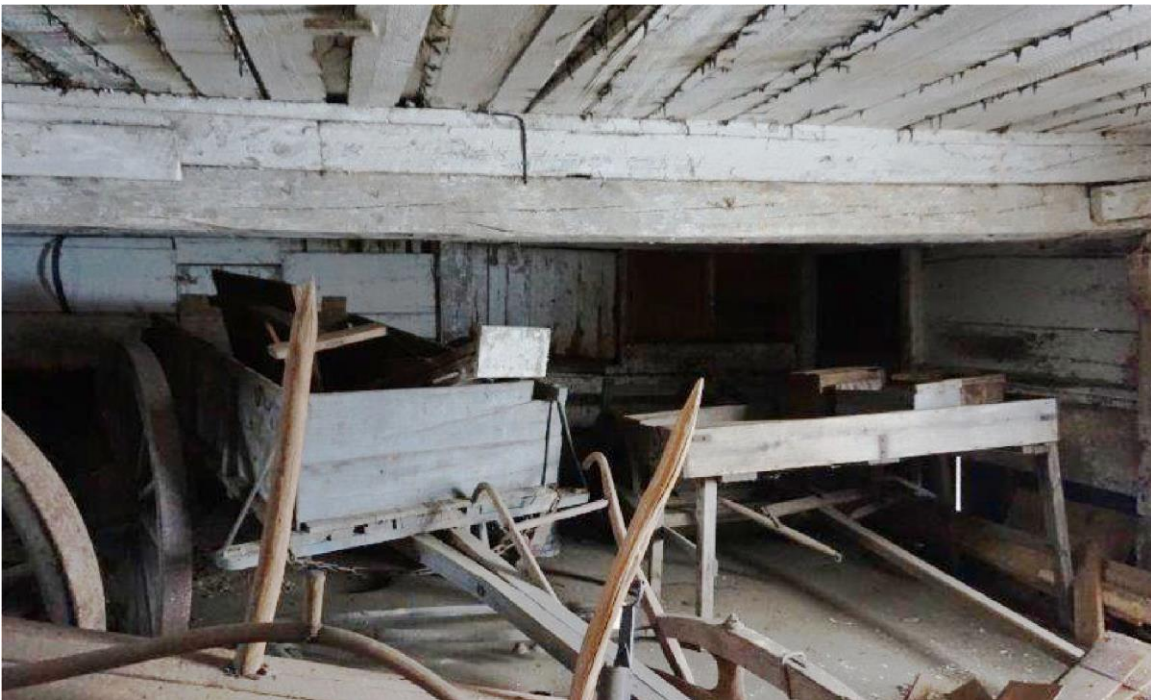
EXPANDED HAY LOFT: The expanded hayloft will be removed, where it was extended out over the threshing floor, thereby blocking the location for the second set of barn doors. The Buckland Historical

Society will inventory their farm implements, with display areas at the animal stalls, and at the hayloft above.

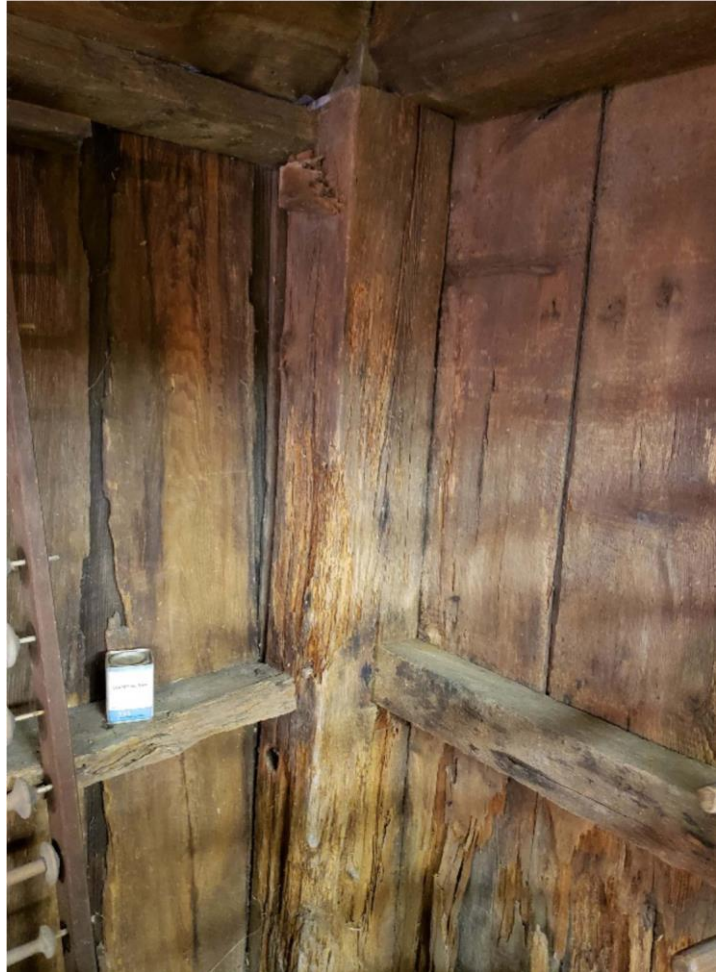
TIMBER AND BARNBOARD DETERIORATION:

A resistance drill was used to determine the integrity of timbers, such as this one at the corner of the weaving room. This timber was sound, although others were not. There are two layers of barnboard for weather tightness. The lower

18 inches +/- are deteriorated, where the lack of foundation leaves the boards touching the ground.

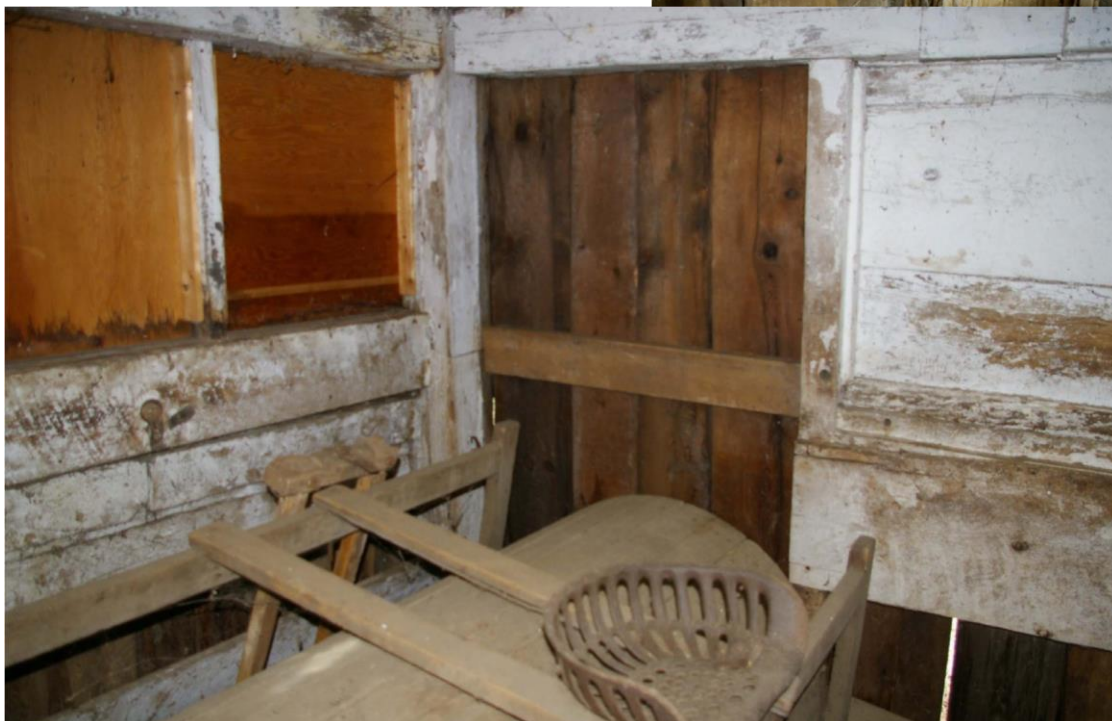
PEOPLE DOORS:

The two corner people doors will be restored at the animal stall area. Period style thumb latches and strap hinges will be used, likely fabricated at a local blacksmith's shop.

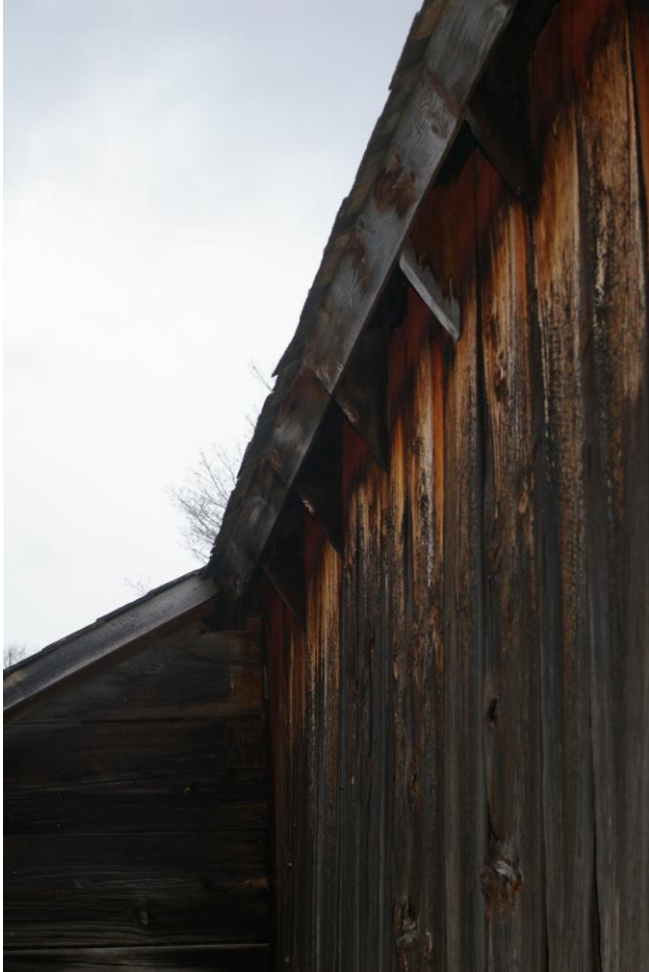
ROOF OVERHANG SUPPORT BRACKETS: This photo is too dark and needs the exposure adjusted. Replacement of any deteriorated or missing roof eave support brackets will be included with the roof restoration. These brackets are similar to the ones on the Little Compton Historical Society's barn, with those supporting wood "V" shaped gutters.

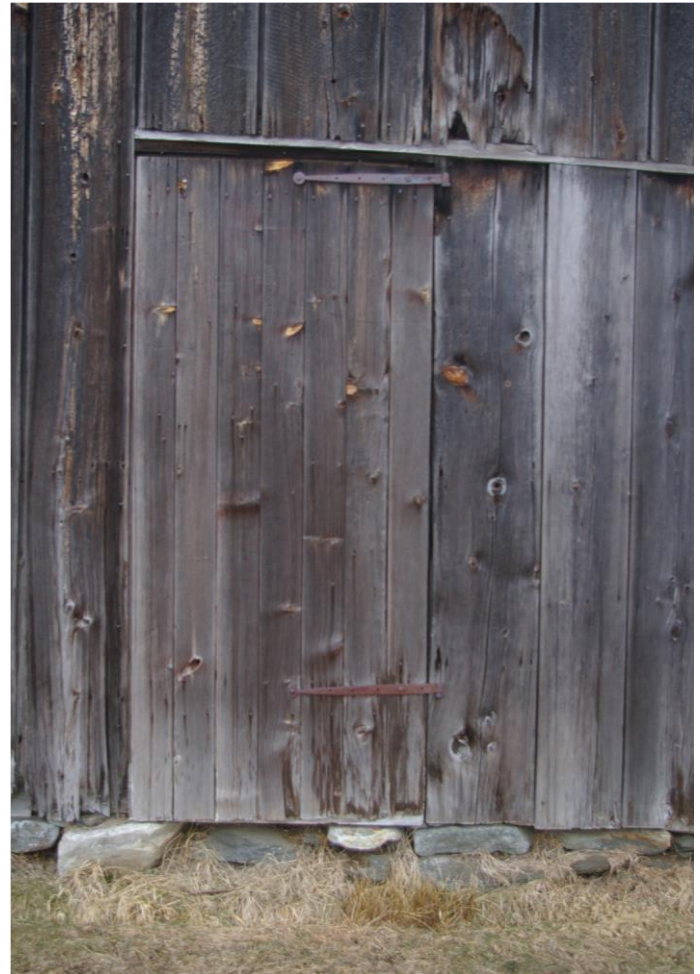
LATER DOOR: This door is not part of the original four bay barn, and is located at the 5th bay, which houses the weaving room on the first floor.

The additional bay is not recent, although it does have a slightly better fieldstone foundation than the original barn. The door with its strap hinges may be salvageable to relocate to the location of the missing animal stall door.

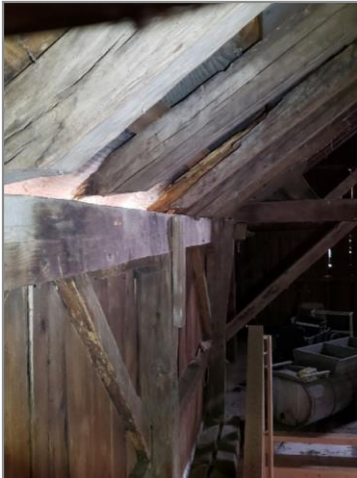
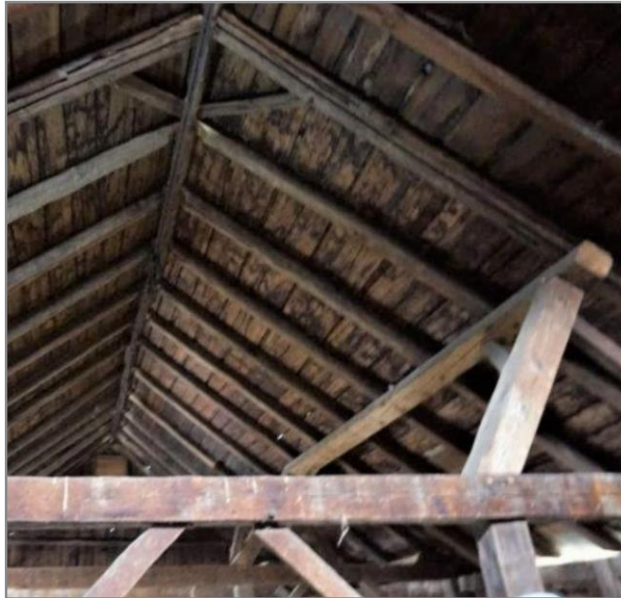
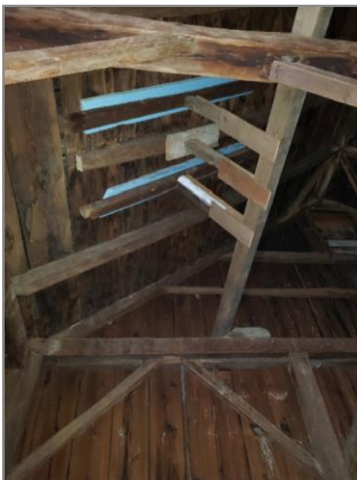
Overall, many of the rafters appear to be in fair condition. There are two areas, however, where past roof repair efforts appear to have left the rafters compromised. These are the same areas that are also missing slates. Referring to the attached plan sketch, along the south eave (grid A) in the third bay of the Main barn (between grids 3 and 4), the bottom end of the one rafter has been sawn off and new end pieces have been spliced on. In this same location permanent shoring has been installed in the form of a newer purlin beam that spans from Bent 3 to Bent 4 and directly supports the rafters (pictured below, left). This shoring seems to have caused a loss of bearing at the bottoms of the rafters as well (below, right).

A second location where the roof framing has been compromised is along the south eave (grid D) in the first bay of framing (between grids 1 and 2). This area is also missing slates. A rafter end has been sawn off and permanent shoring has been installed (pictured left).

The recommendation at this location is to shorten the posts that support the permanent shoring beam, allowing a small gap between the rafters and beam, while also allowing the ends of the rafters to be supported by the wall plate timber. The small gap should be shimmed and fasteners should be installed attaching the rafters to the purlins. Similarly, fasteners should be installed at the base of rafters, securing the members to the wall plate timber. Additionally, because these rafters act as both beams and posts, the rafter that has been cut should be sistered with new framing that spans from the ridge pole to the eave. The new framing should be fastened to the existing rafter as well as at the ridge and eaves.

The recommendation at this location is to sister the existing rafter with new full length framing that spans from the ridge pole to the eave and is anchored at each end as well as along its length.

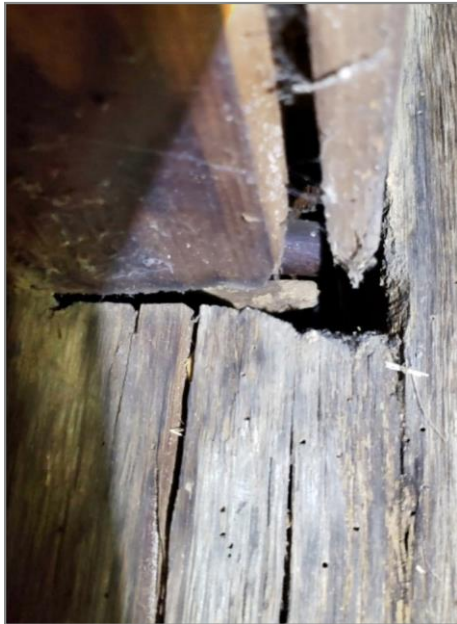
Two locations along the south wall plate showed signs of distress. The first location was at the connection between the wall plate and the gunstock post at the tie beam along grid 2. At this location the wood in the wall plate appears to have deteriorated, likely due to repeated exposure to moisture at some, possibly prior to the more recent roof repair efforts (pictured left, shining

flashlight at underside of wall plate into connection with gunstock post). At the time of the visit, the area was observed to be dry and it is not clear how long this condition has existed. The connection of the tie beam to the gunstock post actually seemed in fair condition but should be more closely investigated. This connection is a critical connection as the tie beam functions to keep the walls from spreading outward and this restraint requires both the tie beam and wall plate to be adequately secured to the post.

The recommendation at this location is to reduce the loads on this connection and prevent moisture from causing further decay. The existing timber is deteriorated but appears to still be whole or intact. Methods to reduce the stress on this connection include installing metal tie rods on either side of the connection that span the width of the barn and are anchored into sound wood. This will provide an alternative path for the lateral loads on the wall plate that does not utilize the post connection. The gravity loads on the beam can be reduced by adding support posts along the wall near this connection. As an alternative, the timber, or a portion of the timber could be replaced in-kind. Special care should be exercised by a Timber framer with experience in historic preservation to match existing joinery work and provide adequate splices if only a segment of the timber is replaced.

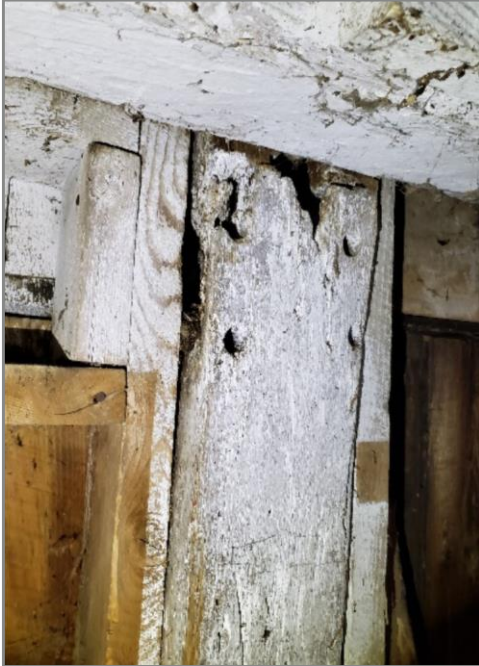
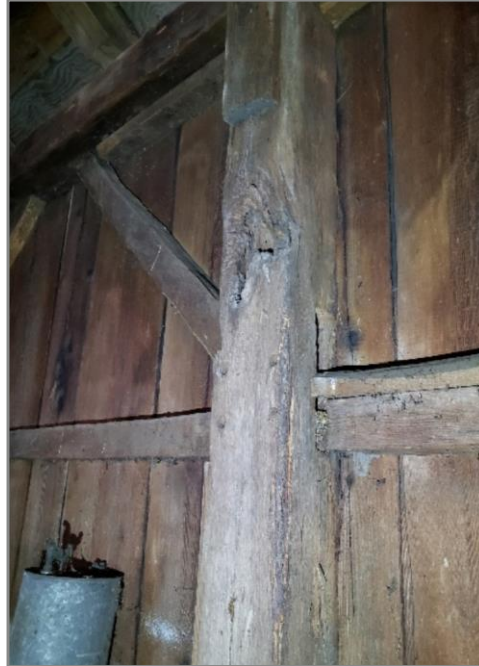
Post A/3.5: Significant deterioration was observed at two locations on this post; first at the first wall girt framing connection, and second near the eave line, which appears to have started as a natural defect in this timber.

The recommendation is to replace this post. The attached resistance drill readings confirm that very little sound wood remains.

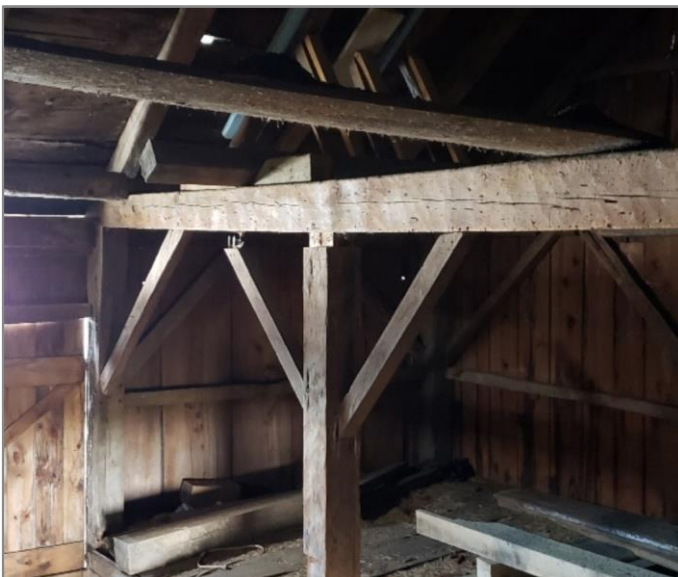
Post C/2: This post appears to have settled and the top is no longer engaged in the tie beam at the eave level. The possible causes of this include an inadequate foundation, overloading from the loft, and/or deterioration of the post base.

The recommendation is to re-use this post. Much of the post appears to be in fair condition. The new design work should include a properly sized foundation, and potential repair work to the base of the post. The post should be re-set into its original configuration.

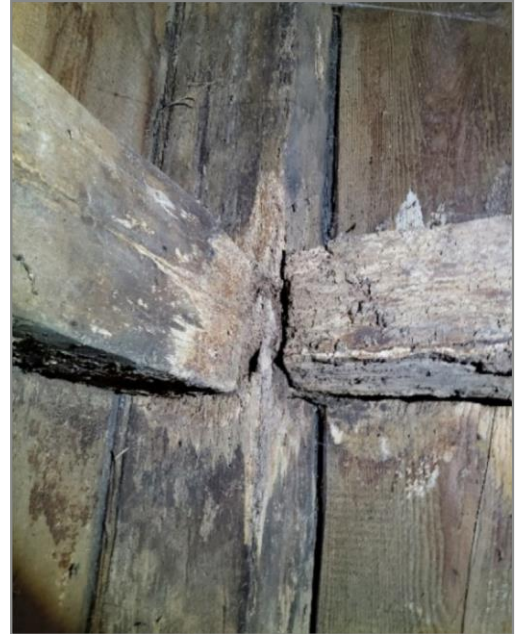
Post D/4: *Deterioration was observed at the location where three wall girts frame into this post. Because of this connection, the section of this post was already reduced, and now the remaining wood appears to be compromised. Resistance drilling confirms that there is deterioration at this joint.*

Much of the post is still in fair condition and could be reused. The recommendation is to strengthen this section of post with timbers that bridge over the damaged area. This will require re-working the connections of the wall girts to the new framing around the post. Alternatively, this lower section of post could be replaced.

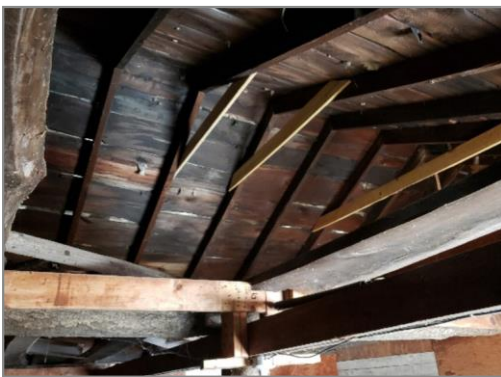
The Shed at the west gable end of the Main barn is framed out of sawn lumber and nailed together rather than timber joinery. The structure is under-framed for any sort of occupancy other than simple utilitarian storage. The roof framing consists of opposing rough sawn rafters spaced at approximately two-feet on-center. This is similar to the Main barn, however in the Shed there are no tie beams or ridge pole. As a result, it appears that the walls have bowed outward some, and efforts were made to restrain this movement by installing one-inch boards as collar-ties (near the peak) and as rafter ties (near the eaves). The collar-ties near the peak do little for the strength of the roof and mostly serve to help hold the framing together. The rafter ties, which consisted of a mix of live edge one-inch boards, may actually be helping restrain the eaves, but the irregularities and inconsistency of the boards make analyzing this framing very challenging.

A substantial amount of work would be recommended in order to lengthen the useful service life of this structure for continued use as a Shed. The work would have to include installing ceiling framing (rafter ties) and strengthening the rafters, sill repair, stud repairs and strengthening, as well as installing some sort of foundation walls or concrete piers.

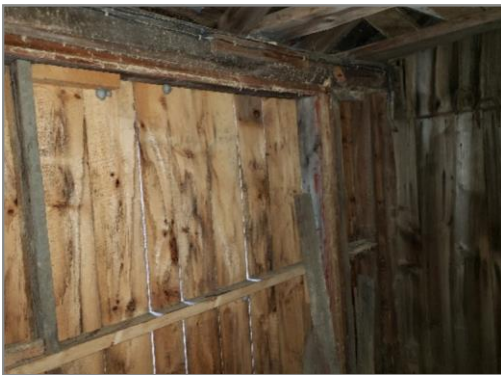
Only a small portion of wall framing was observable; much of the interior has been sheathed with plywood which has likely contributed to the Shed's overall stability despite being so lightly framed. The portion of wall framing that was observable appears to be infill framing where a large opening once was. The beam over this opening has deflected significantly and the newer infill framing offers little additional support.
