Buckland Historical Society

Architectural Restoration and Educational Resource Plan

For an English Style Barn
at the Wilder Homestead Property

Structural Assessment Prepared by:
Stevens & Associates, P.C. June 17th, 2020

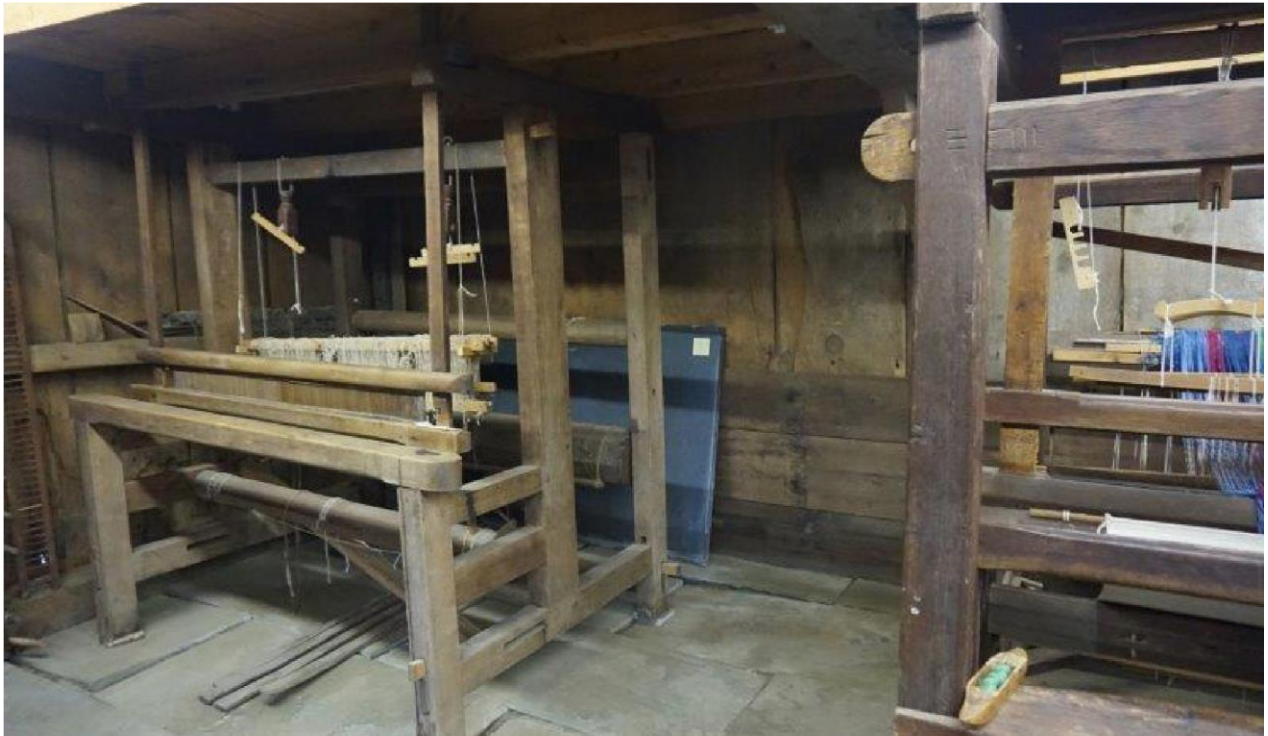
THE LOOMS: Antique barn looms, similar to the ones used by Eleanor Wilder Clark and “The Buckland Weavers” will remain on display in the weaving room. The blue stone pavers will be replaced with a wide plank pine floor, with heating ductwork concealed beneath the floor, extending the season for weaving.

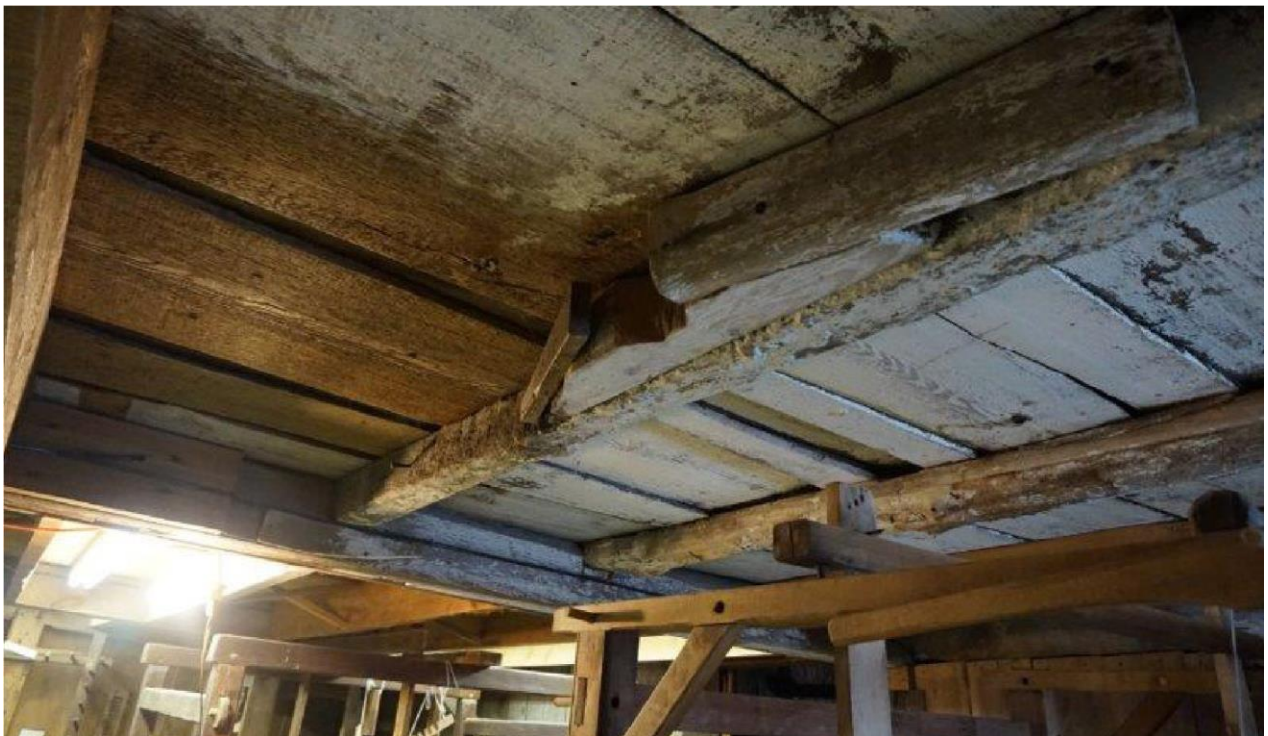
WEAVING ROOM INSULATION: The loft floor framing serves as a ceiling to the weaving room. The framing will be strengthened to support loads at the loft above. The loft framing, along with the walls of the weaving room, will be insulated and finished with barnboard.

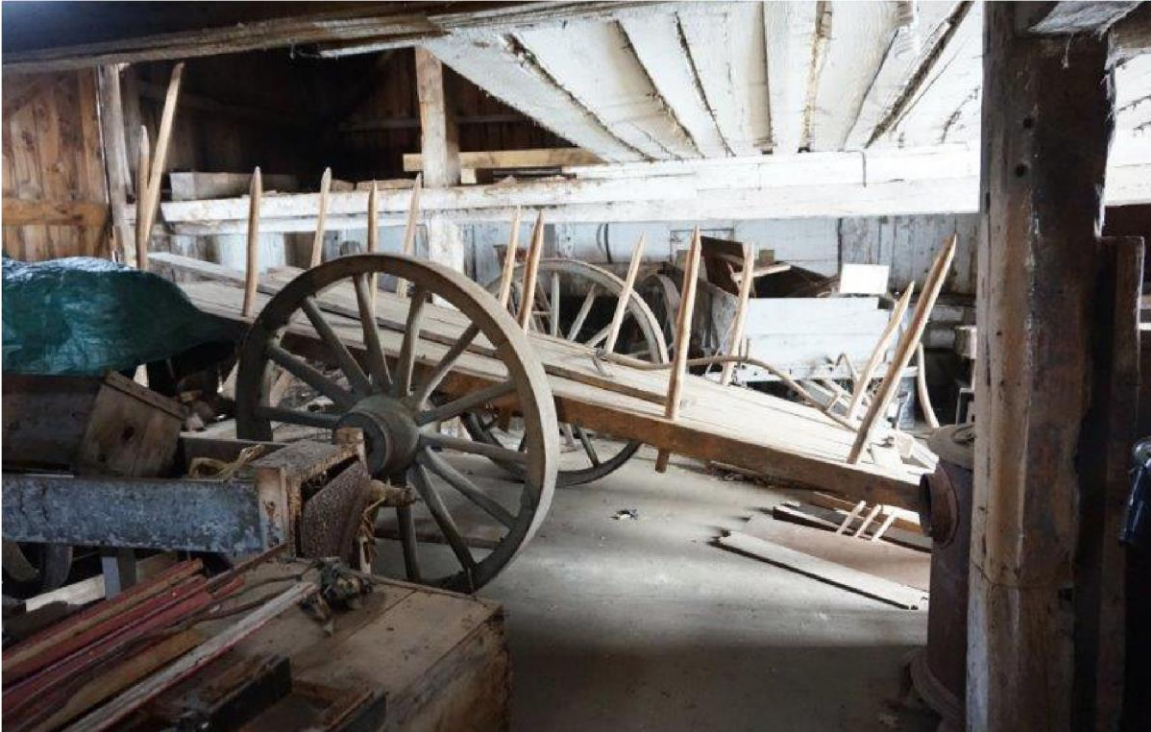
THRESHING FLOOR: The hay wagon is located where the threshing floor will be restored, with a second set of barn doors installed where they were previously removed. The current asphalt floor will be replaced with wide pine planks, cut from trees on the Wilder homestead land.

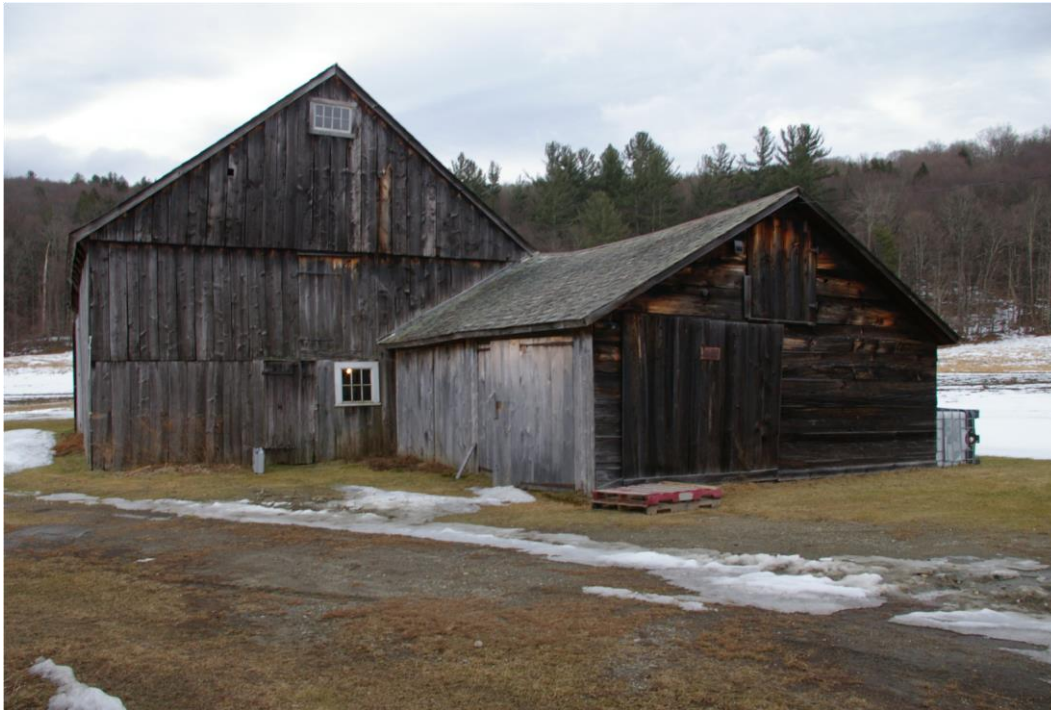
WEAVING ROOM ENTRY & ADDITION: The door to the left of the window is the entrance to the weaving room. This door, along with other public entries will be made accessible with a removeable wooded ramp. A wood grab bar will be placed beside each entry door. This was an effective solution used at our previous colonial period barn restoration in Little Compton, RI. Accessibility was provided, while maintaining the historic character of the barn.

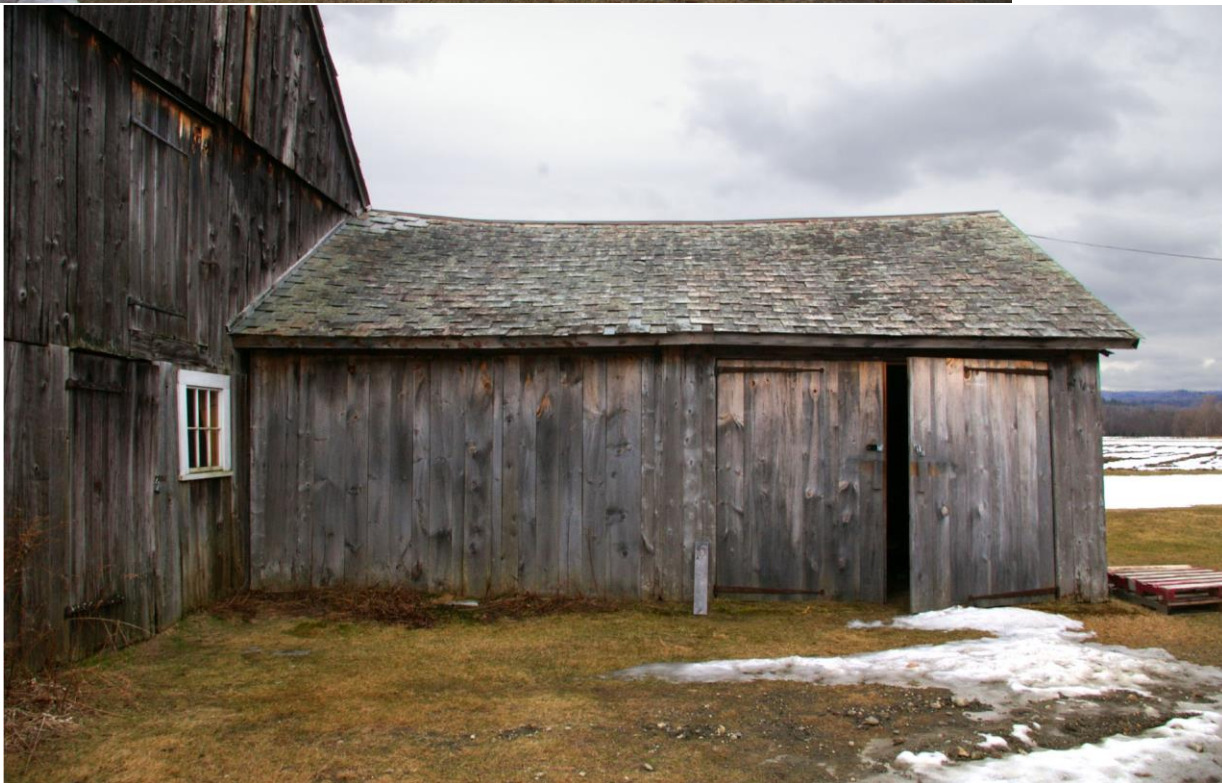
CATERING KITCHEN & RESTROOMS: The garage addition to the barn is beyond repair and will be demolished with a new addition constructed in its place. The addition will approximately fit the footprint of the existing garage, with the same exterior barnboard siding, door with strap hinges, and slate roof. The intent will be to maintain the character of the barn.

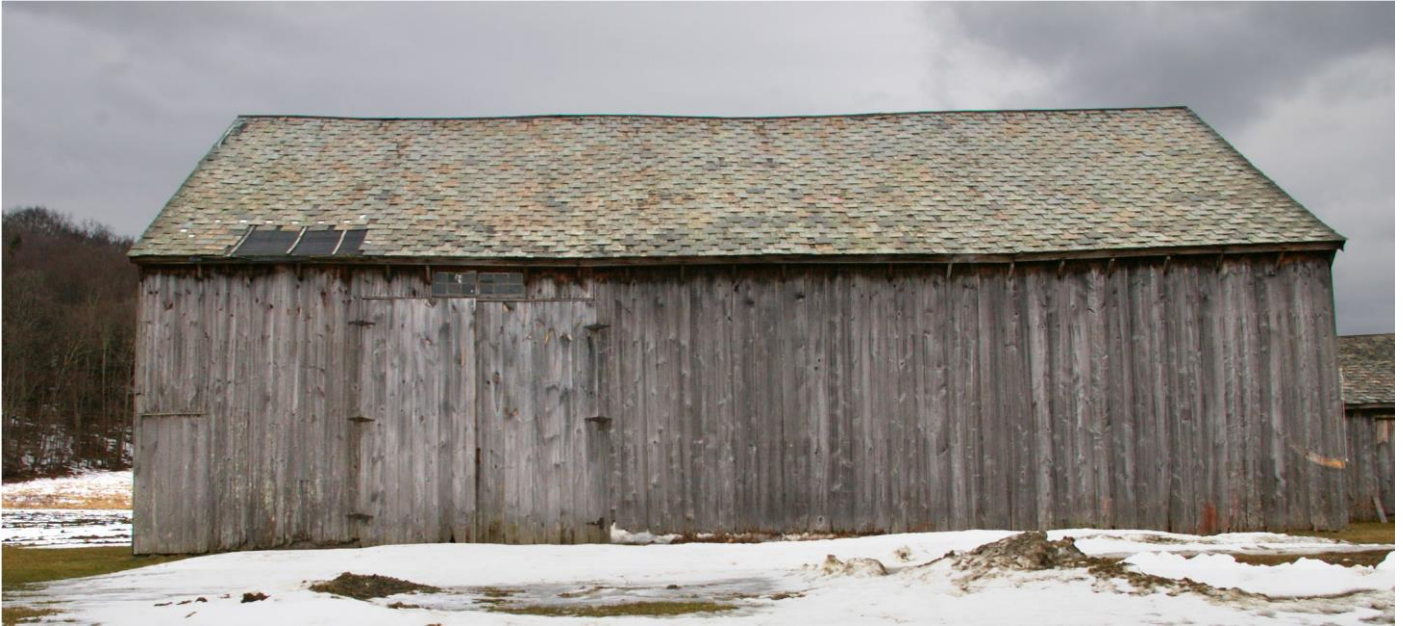
NORTH FAÇADE: With a new concrete foundation, concealed by a fieldstone veneer, the sill plates will be out of the dirt and protected from rot. An earthen ramp will provide at grade access to the barn doors, and the threshing floor inside. The slate roofing shingles will be removed and reinstalled following framing and roof deck repairs. Additional slate will be required to replace broken slates and to repair areas missing slate, such as the area above and to the left of the barn doors.

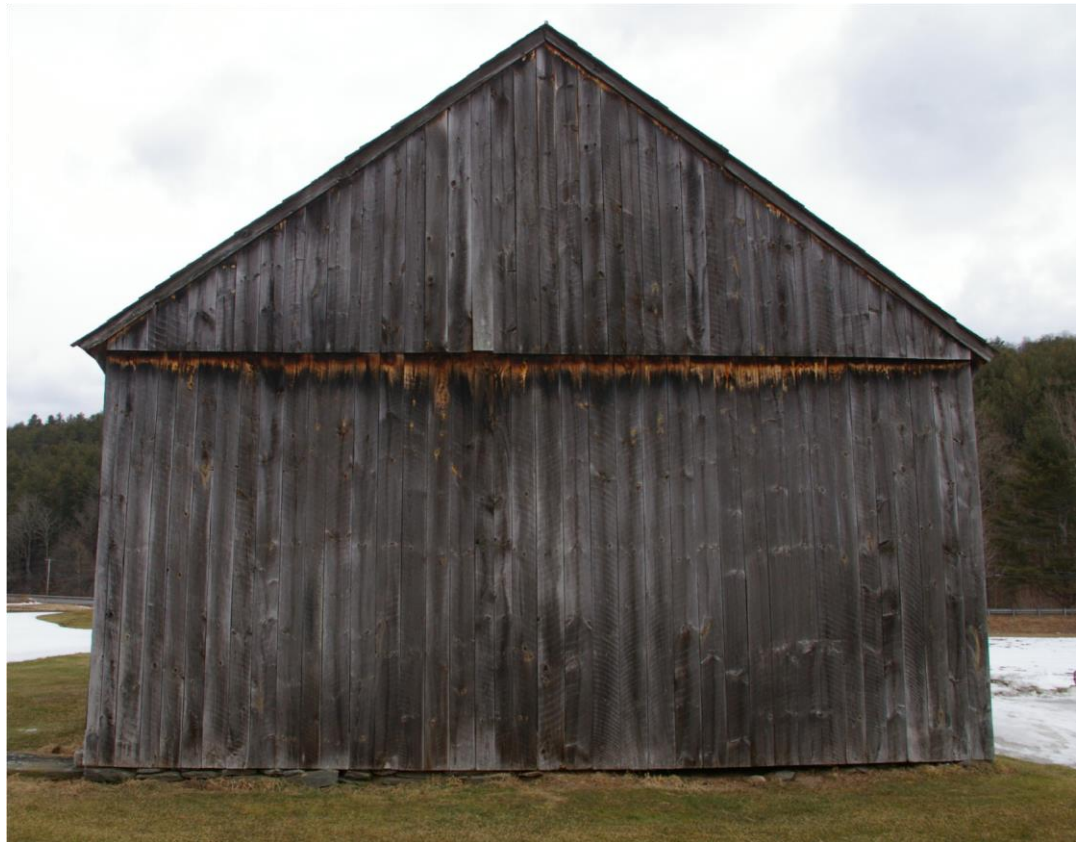
EAST FAÇADE: The barnboard on the east façade has been recently replaced, and does not have the deterioration along the lower eighteen inches as the other exterior walls have. The height of the existing minimal fieldstone foundation will be increased to keep the wood off the ground. A hayloft vent window will be added high up the gable to match the window on the west façade.

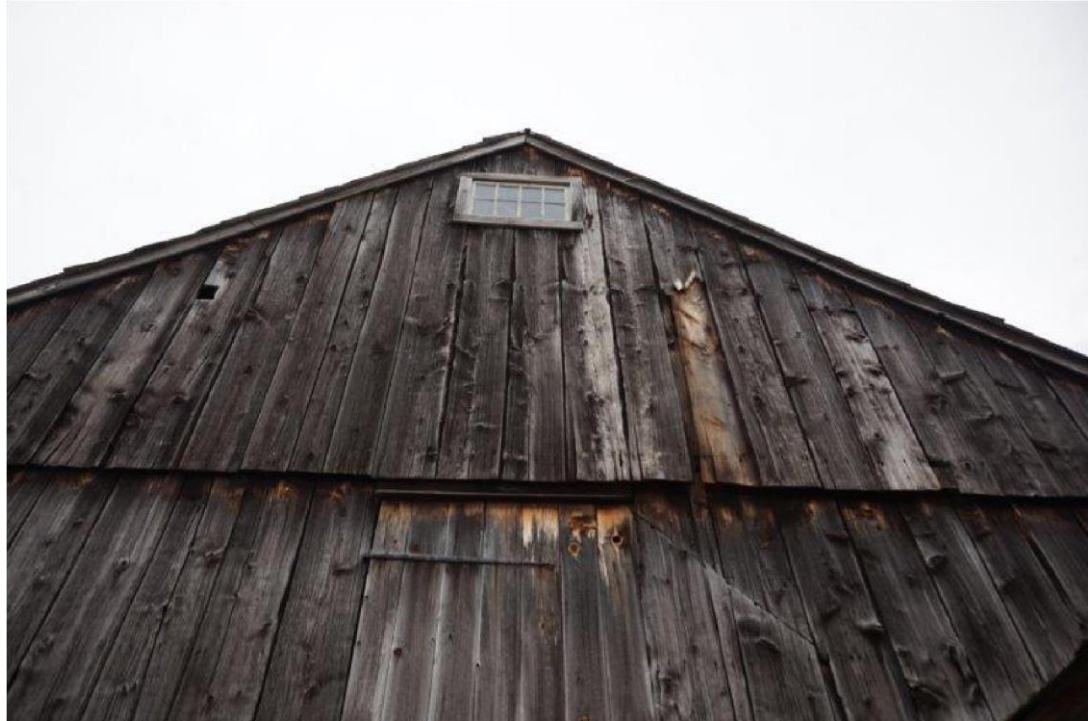
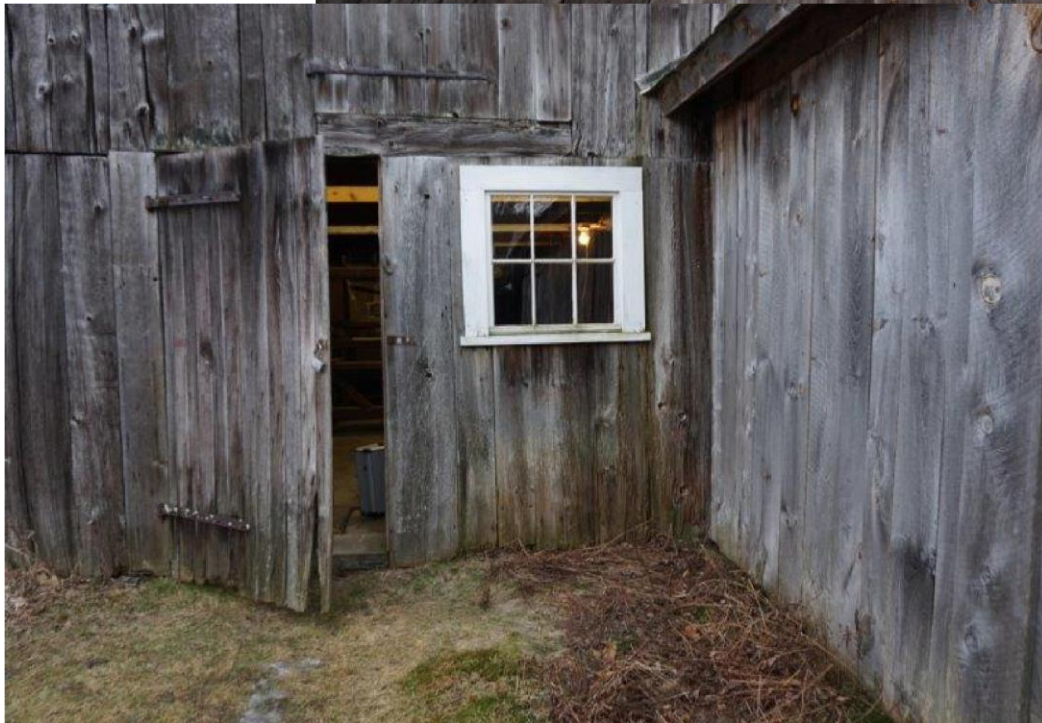
WEAVING ROOM ENTRY & HOPPER WINDOW:

The window to

the right of the entry door to the weaving room, like the other first floor windows of the barn, is a hopper style window that opens in, without letting rain inside, except during more severe storms. A matching window will be added at the opposite side of the door, in order to bring more natural light into the weaving room. Similar windows will be used at the kitchen / restroom addition, which will replace the current garage.

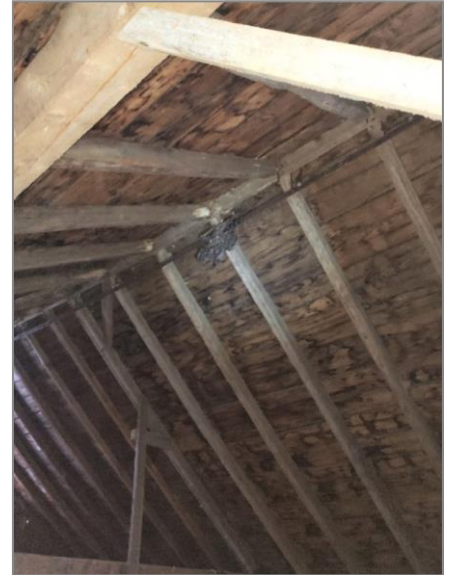
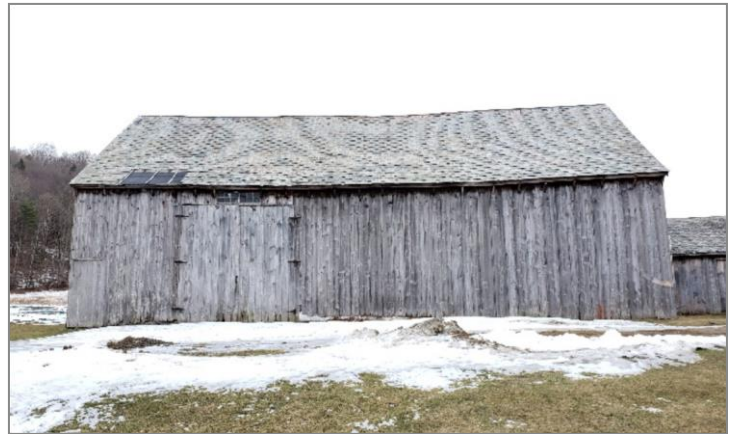
Overall, many of the rafters appear to be in fair condition. There are two areas, however, where past roof repair efforts appear to have left the rafters compromised. These are the same areas that are also missing slates. Referring to the attached plan sketch, along the south eave (grid A) in the third bay of the Main barn (between grids 3 and 4), the bottom end of the one rafter has been sawn off and new end pieces have been spliced on. In this same location permanent shoring has been installed in the form of a newer purlin beam that spans from Bent 3 to Bent 4 and directly supports the rafters (pictured below, left). This shoring seems to have caused a loss of bearing at the bottoms of the rafters as well (below, right).

The recommendation at this location is to shorten the posts that support the permanent shoring beam, allowing a small gap between the rafters and beam, while also allowing the ends of the rafters to be supported by the wall plate timber. The small gap should be shimmed and fasteners should be installed attaching the rafters to the purlins. Similarly, fasteners should be installed at the base of rafters, securing the members to the wall plate timber. Additionally, because these rafters act as both beams and posts, the rafter that has been cut should be sistered with new framing that spans from the ridge pole to the eave. The new framing should be fastened to the existing rafter as well as at the ridge and eaves.

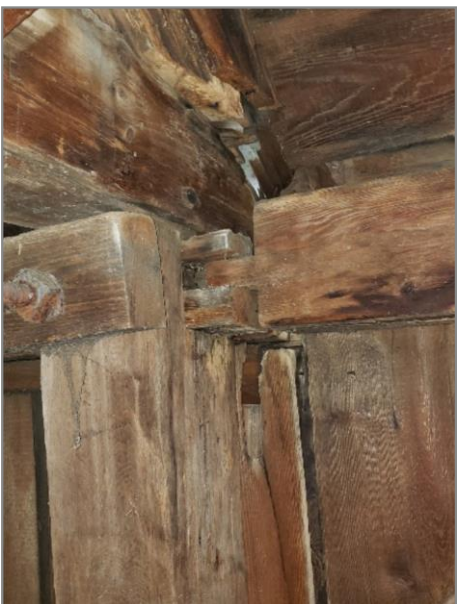
Two locations along the south wall plate showed signs of distress. The first location was at the connection between the wall plate and the gunstock post at the tie beam along grid 2. At this location the wood in the wall plate appears to have deteriorated, likely due to repeated exposure to moisture at some, possibly prior to the more recent roof repair efforts (pictured left, shining

flashlight at underside of wall plate into connection with gunstock post). At the time of the visit, the area was observed to be dry and it is not clear how long this condition has existed. The connection of the tie beam to the gunstock post actually seemed in fair condition but should be more closely investigated. This connection is a critical connection as the tie beam functions to keep the walls from spreading outward and this restraint requires both the tie beam and wall plate to be adequately secured to the post.

The recommendation at this location is to reduce the loads on this connection and prevent moisture from causing further decay. The existing timber is deteriorated but appears to still be whole or intact. Methods to reduce the stress on this connection include installing metal tie rods on either side of the connection that span the width of the barn and are anchored into sound wood. This will provide an alternative path for the lateral loads on the wall plate that does not utilize the post connection. The gravity loads on the beam can be reduced by adding support posts along the wall near this connection. As an alternative, the timber, or a portion of the timber could be replaced in-kind. Special care should be exercised by a Timber framer with experience in historic preservation to match existing joinery work and provide adequate splices if only a segment of the timber is replaced.

It is also recommended to inspect all of the other connection locations where the tie beams are joined to the exterior columns.

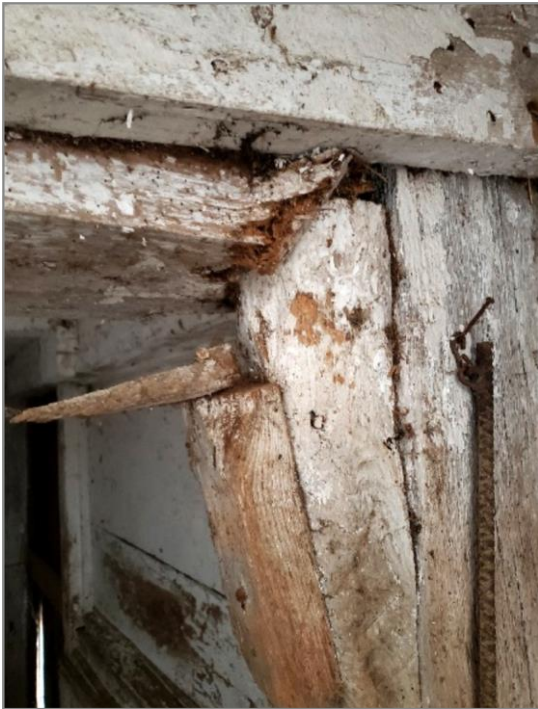
There are very few interior beams in the Main barn. Aside from the tie beams already discussed, there are three beam lines along grids 2, 3, and 4 that are approximately 6-ft above ground level. The only beams that show clear signs of distress or deterioration are the two beams along grid 2. These beams support the interior edge of the loft at the west gable end of the structure. The beams have deflected significantly and show signs of crushing failure at their bearing locations (pictured left). Past repairs are also evident such as adding beams below and alongside the framing.

The recommendation at this location is to clear off the loft space and no longer use it for storage, or very light storage at the most. The distress seen in the beams is likely a result of this loft being overloaded. If the loft remains vacant, then the existing beams can remain, and the recommendation is to strengthen the damaged connections at the ends of the beam and restore bearing.

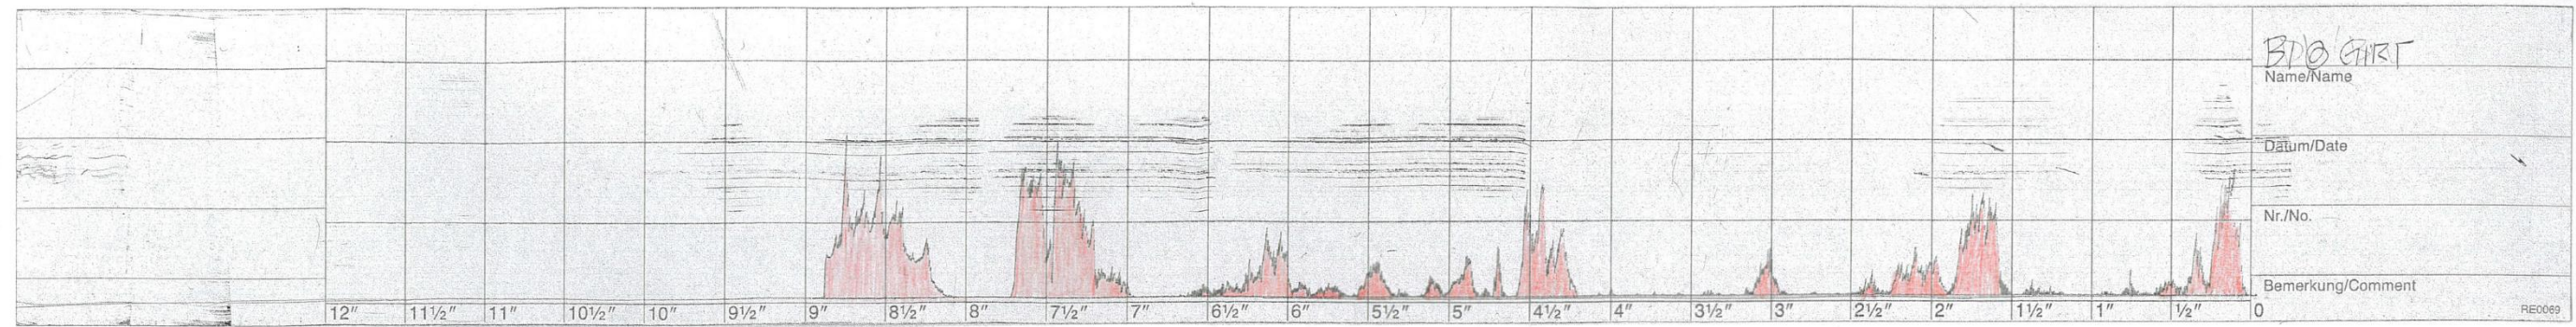
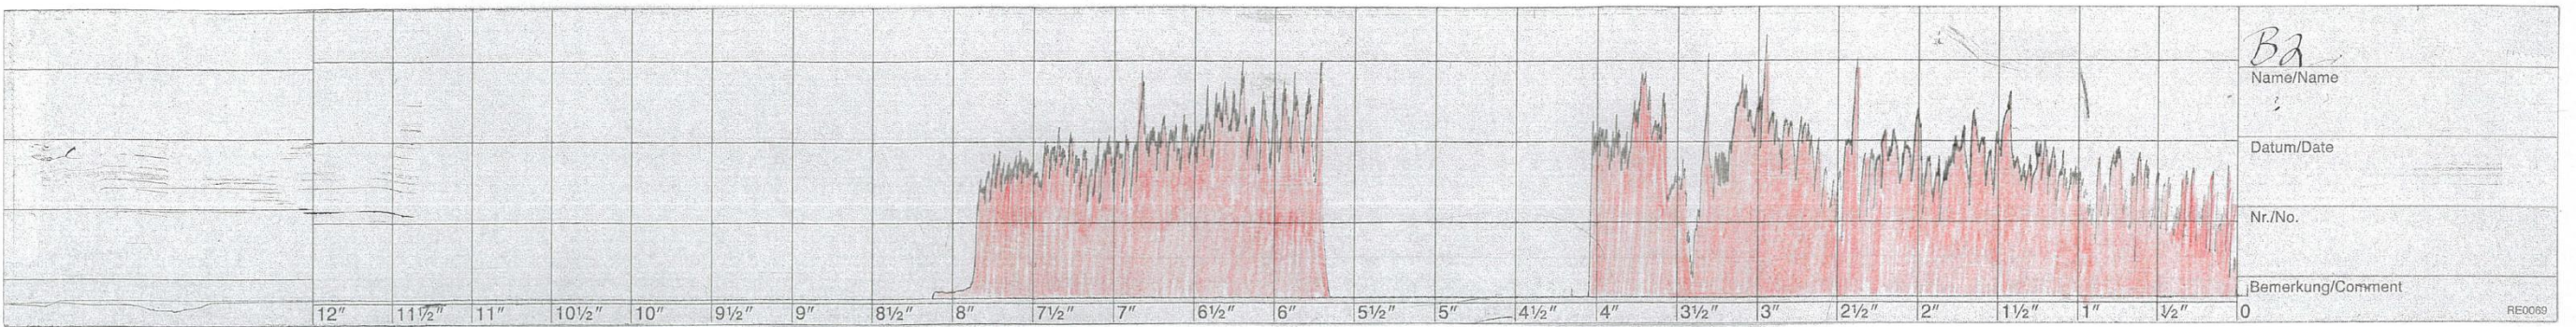
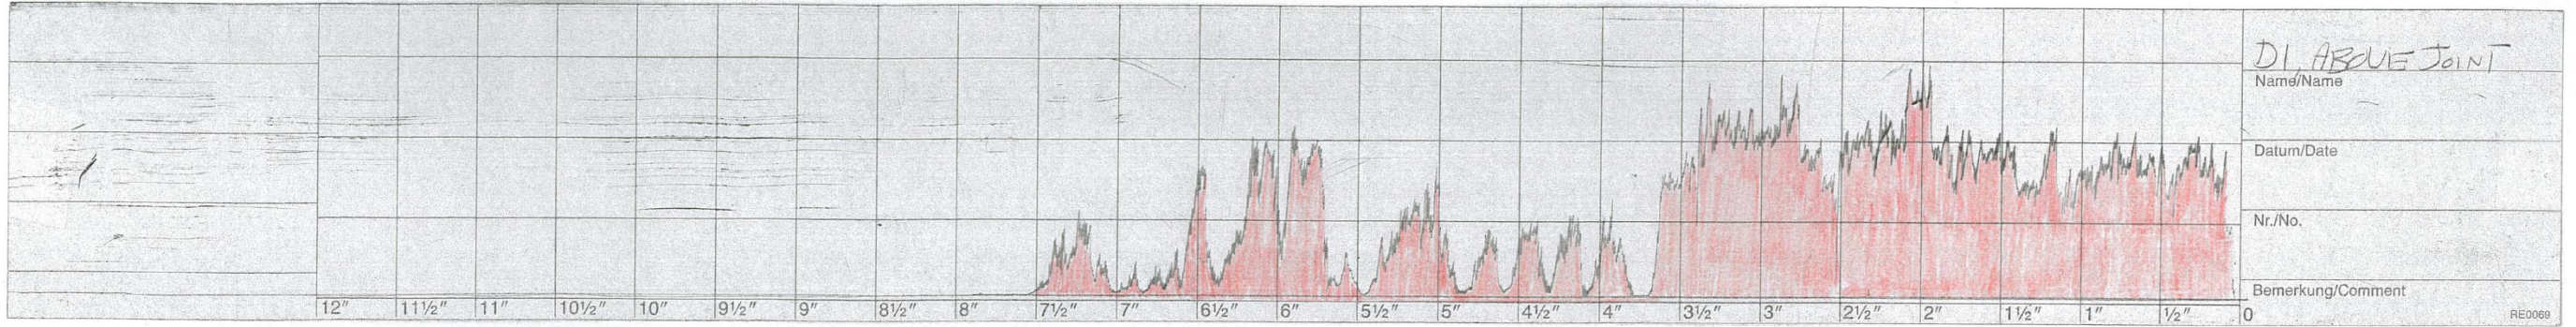
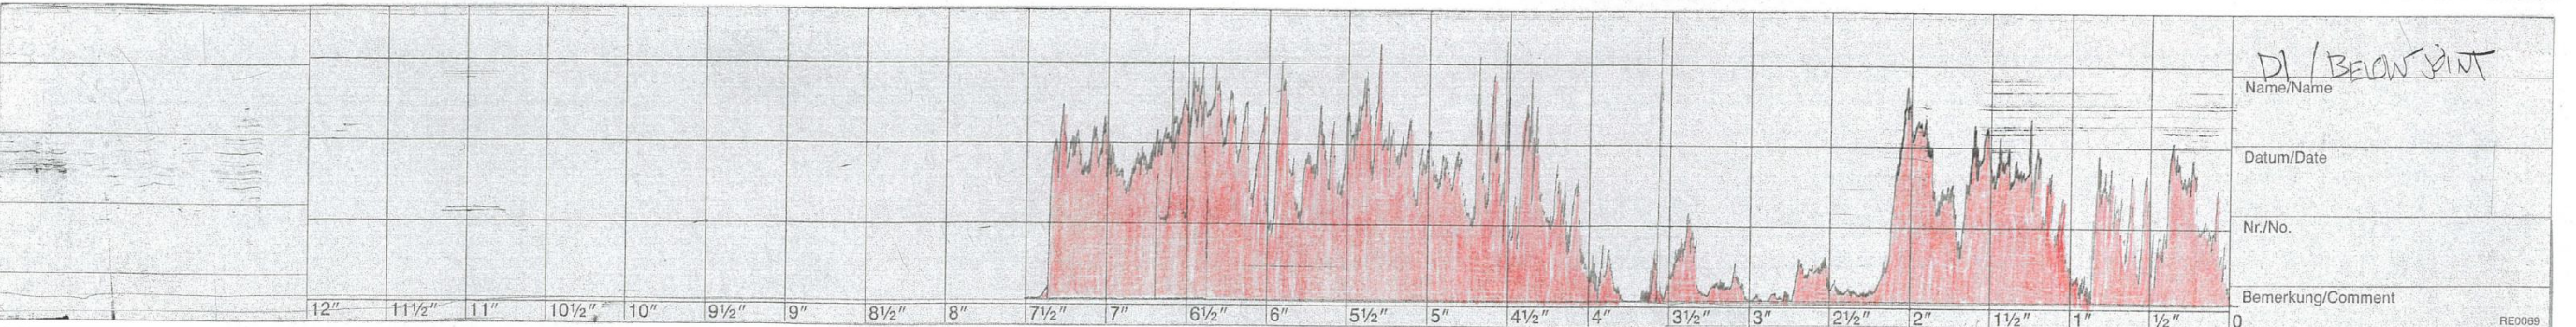
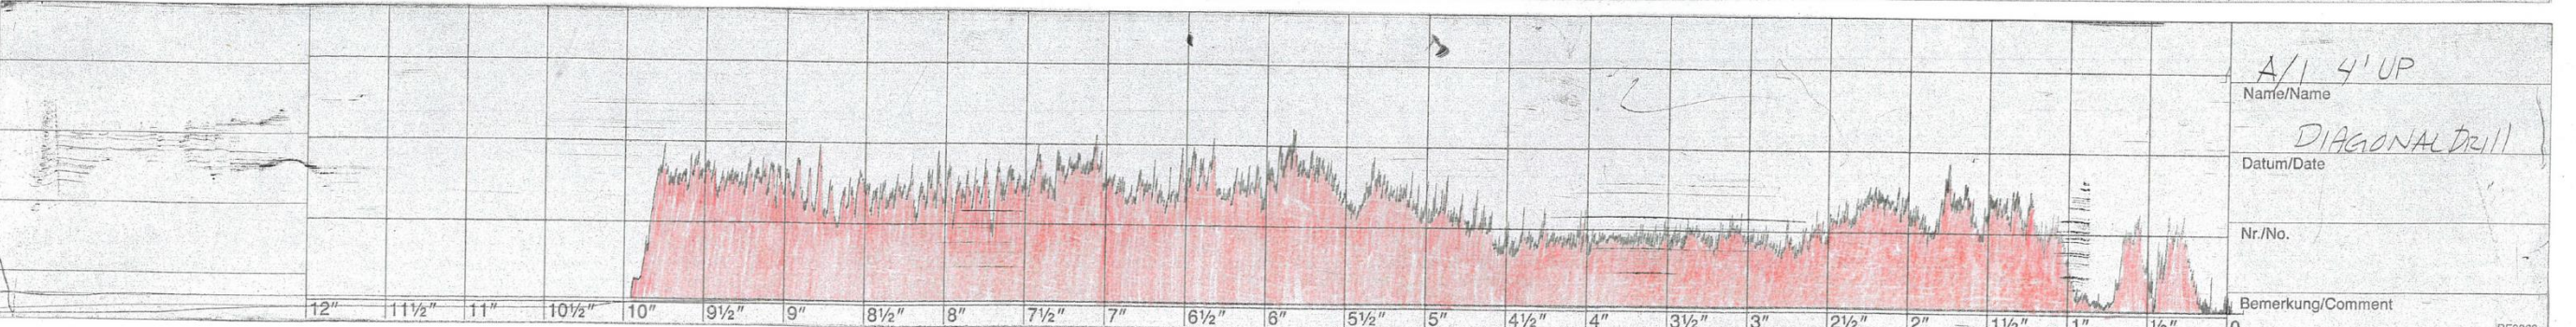
Resistance Drill

Post A/3.5: Significant deterioration was observed at two locations on this post; first at the first wall girt framing connection, and second near the eave line, which appears to have started as a natural defect in this timber.

The recommendation is to replace this post. The attached resistance drill readings confirm that very little sound wood remains.
